# The Behavior of Thermal Shock Repairing of High Strength Reinforced Concrete Beam Using NSM-CFRP Rope and Strip

## Abstract

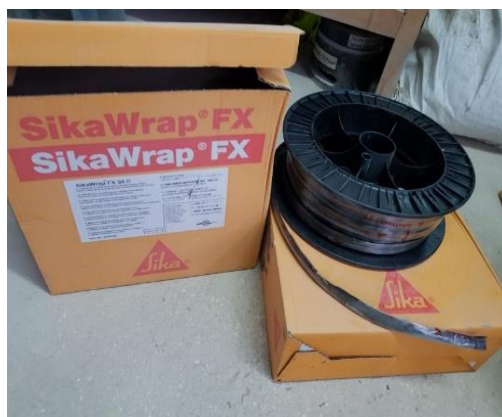
**Fig. 1** SikaWrap FX 50C CFRP ropes.

For specimen strengthening, commercially available CFRP ropes (SikaWrap FX-50C) and CFRP strips (Sika) were combined with (SikaDur 52) saturating resin. As for the adhesive, it was utilized in two parts, combined in accordance with the manufacturer's instructions (SikaDur 330). The commercial provider (Sika AG) provided all the CFRP and adhesive materials in Fig. 1.

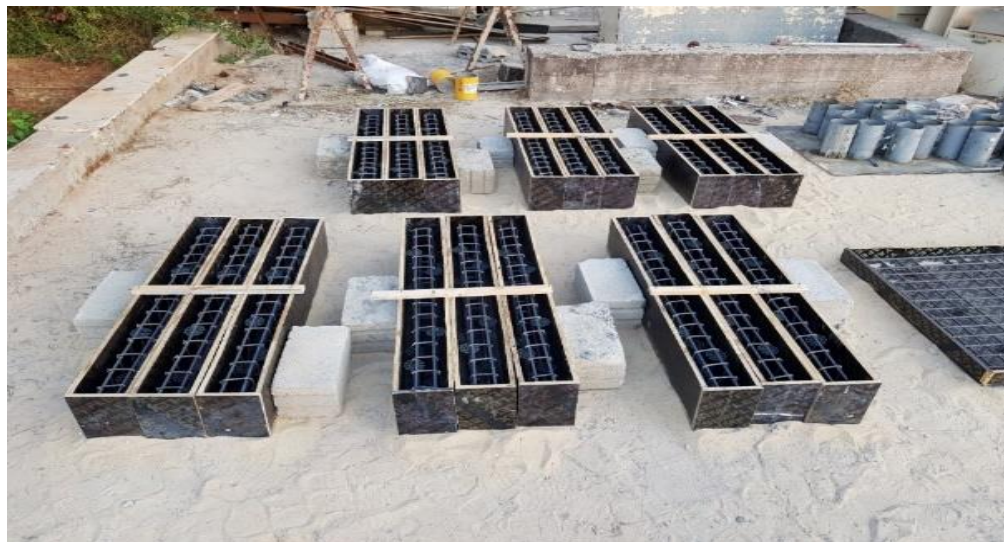
Fig. 3 Casting molds fastened and prepared for concrete casting on a sand surface.

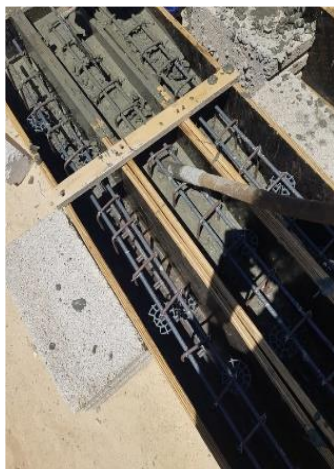
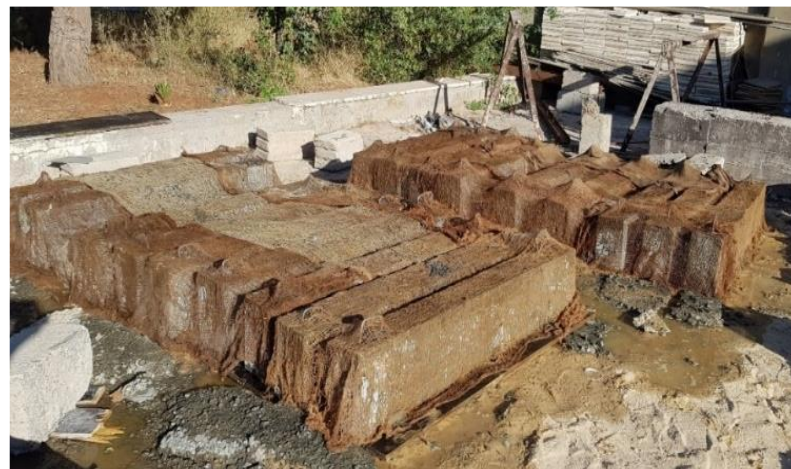
Electric concrete vibrator

Beams covered in burlap for curing

Fig. 4 casting and curing process.

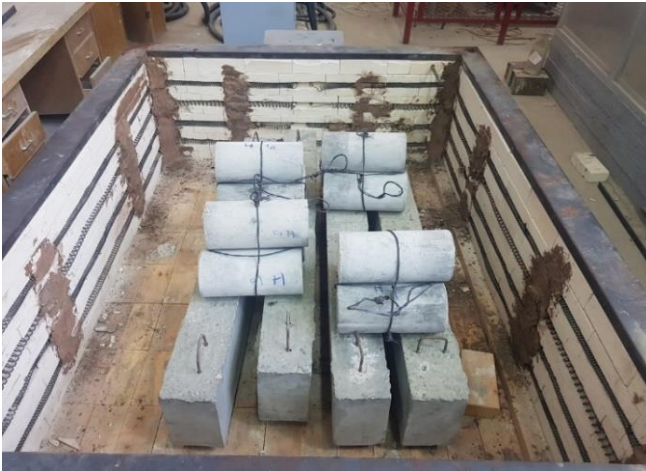
Fig. 7 Testing electric furnace.

The specimens were heated in an electrical furnace with internal measurements of  $2 \times 1.5 \times 1$  m (Fig. 7). The furnace has temperature sensors and a control module to adjust the times and temperatures, and its maximum power is 24 kW. Based on temperature, RC beams have been divided into three groups for this experimental study. The temperature of the first category was normal, the second category was exposed to 500 °C., and the third category was subjected to 700 °C. After the RC beams were placed into the furnace, the temperature was raised to the desired level. Beam specimens remained at the required temperature for three hours. In Fig. 8, the rate of heating is displayed.

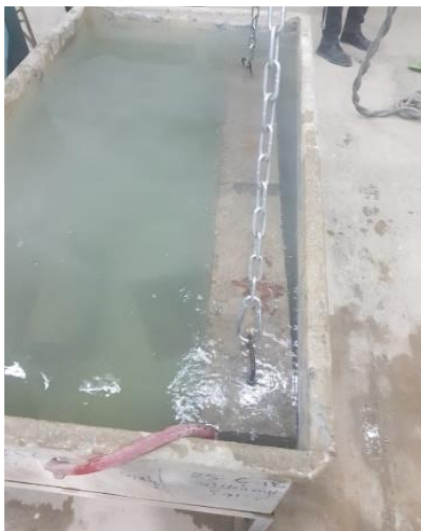
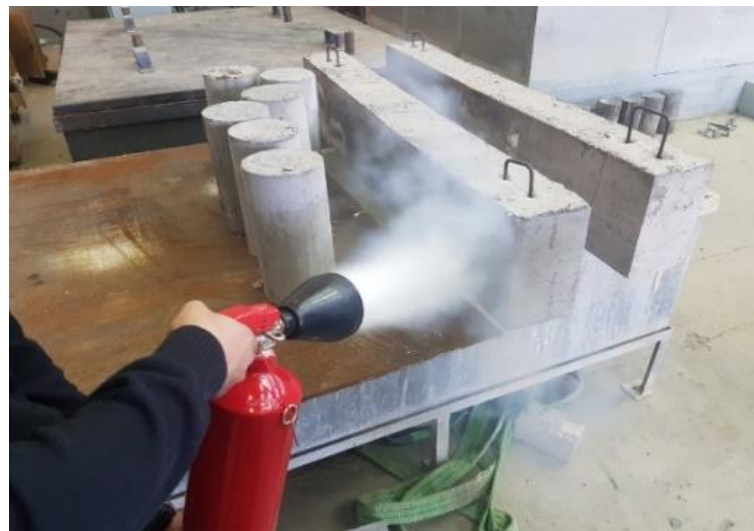
Fig. 9 Placement of specimens into water and Cooling of specimens using a CO<sub>2</sub> fire extinguisher.

The furnace lid is safely opened after the heating cycle is complete. As seen in Fig. 9, the beams are transported by the crane one at a time to be quickly cooled either by immersion in a ready water tank nearby or by a CO<sub>2</sub> extinguisher. Since this procedure is dangerous, safety measures were implemented while emergency professionals were present in the lab. The cracks produced on by the heat shock are markedly visible when the beams have cooled to ambient temperature. The specimen then undergoes the CFRP

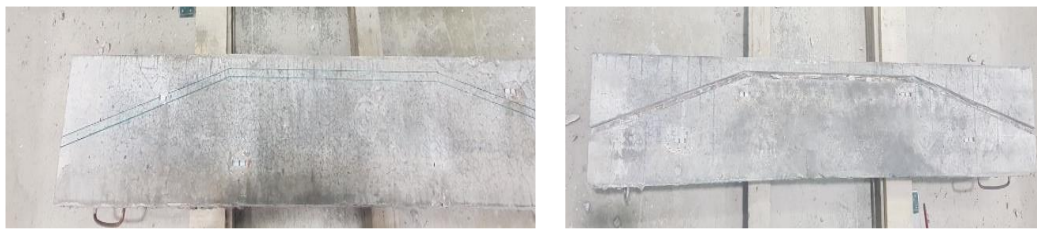
**Fig. 10** Outlining the grooving perimeters and Grooving using a rotary saw blade.

To make the edges of the grooves more visible, the beams were painted an obvious white. The beam was correctly oriented before the groove outlines were precisely drawn on the beam in accordance with the schematics, as illustrated in Fig. 10. As illustrated in Fig. 10. The grooves and anchors were cut with an electric rotary saw blade, chipped with a hammer, and cleaned. The mid-span cross-section detailing grooves for 'Configuration 1' are shown in Fig. 11 and have dimensions of 8 mm wide and 25 mm deep for the strips and 15 mm wide and 25 mm deep for the ropes.

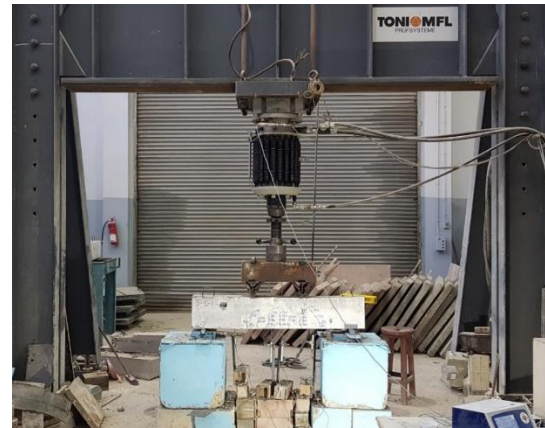
**Fig. 13** Flexural test setup.

**2.5.3 Test Setup** At the University of Jordan's Structures Lab, the specimens were placed to the test using a 4-Point static load hydraulic jack to determine their flexural capacity and response. To measure the linear displacement of the specimens under load, two LVDTs were mounted on the beam mid-span and two more at each one-third point of the span; the LVDT is connected to a data gathering device. The test setup and control devices are shown in Fig. 13. Using Load control, the

load increased gradually at a constant rate of 3 kN/sec. A data acquisition system was used to capture the test results.

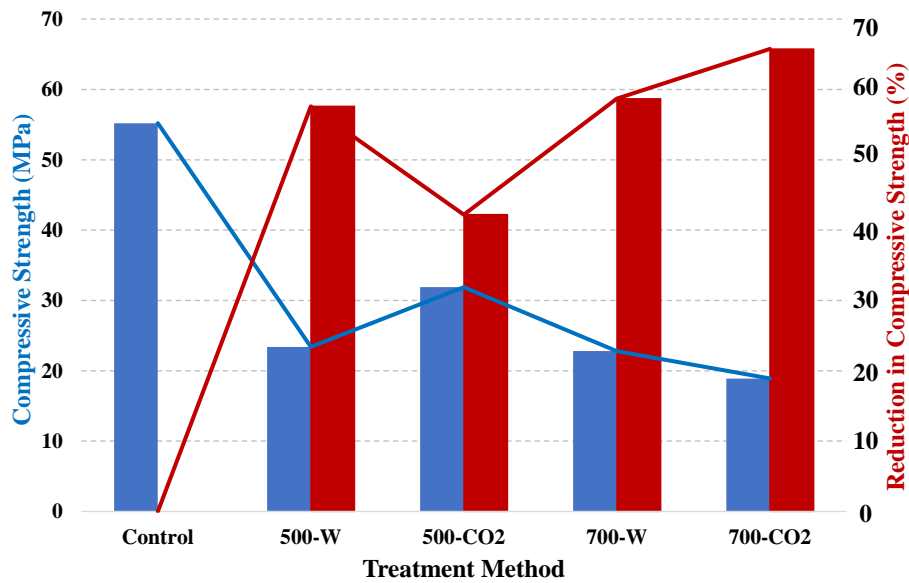
Fig. 14 Compressive stress results.

strength loss at high temperatures.<sup>[9]</sup> At 700 °C compared to 500 °C, the drop in compressive and tensile stress was more pronounced. A higher temperature above 150 °C will result in a decrease in concrete's compressive and tensile strength due of the loss of free absorbed water and the decomposition of Ca (OH)<sub>2</sub>.<sup>[57,58]</sup> This finding is supported by other investigations.<sup>[9]</sup> However, the cooling technique had a temperature-dependent impact; as shown in Fig. 14, water cooling resulted in a more notable loss of strength than CO<sub>2</sub> fire extinguisher at 500 °C than it did at 700 °C. Regardless of the heating temperature, water cooling reduced compressive stress to almost the same level (58% capacity decrease at 500 °C and 59% at 700 °C). According to,<sup>[11]</sup> typical concrete's compressive strength decreased by 28% to 35%. The decrease for water cooling beyond 500C was shown in<sup>[13]</sup> to be 30%. Temperature had a minor impact on tensile strength loss, with a 55% decrease at 500 °C and a 60% retention at 700 °C. Cooling by CO<sub>2</sub> decreased the compressive strength 42% at 500 °C, 66% at

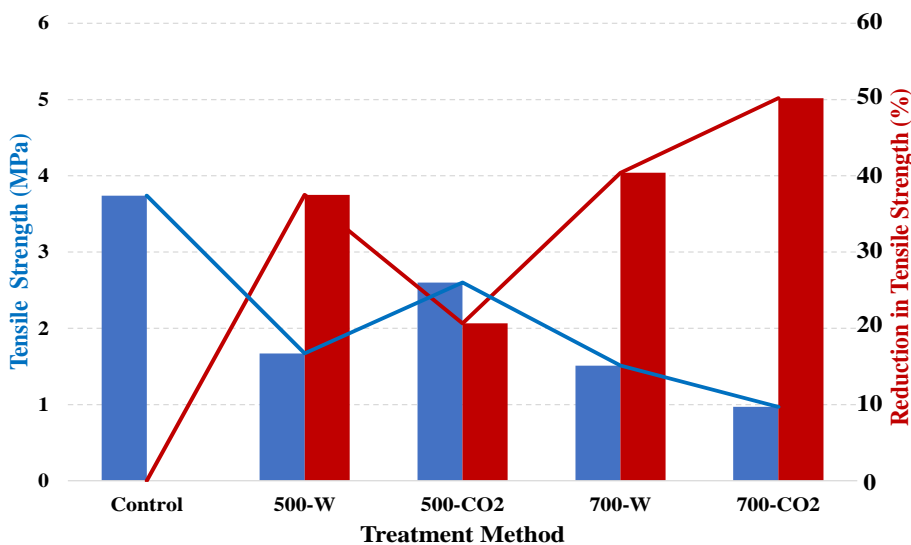
Fig. 15 Tensile stress results.

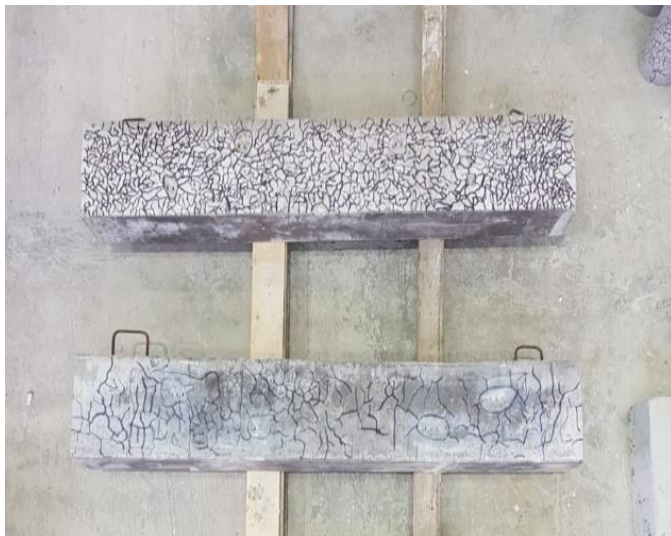
Fig. 16 Spider web cracks caused by heat-shock.

The heat shock cracks were mapped after the beams were cooled to room temperature. Spider web thermal cracks, as seen in Fig. 16, developed at both elevated temperatures due to the quick loss of water content in concrete and the expansion of the concrete under thermal strain. According to

Fig. 16, cooling by water immersion generated highly dense and narrow cracks, whereas cooling by CO<sub>2</sub> fire extinguisher produced less dense but wider cracks. The cooling technique had an impact on the density and form of the spider web thermal cracks in the concrete.

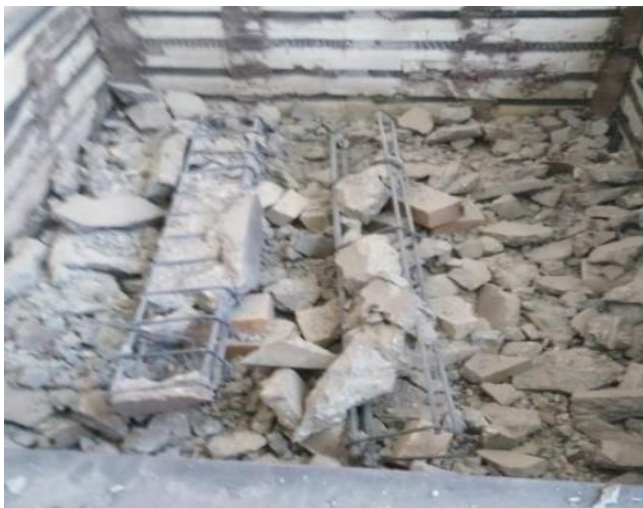
**Fig. 18** Explosive spalling of beam specimens.

the yield point, tapers as it approaches the ultimate load, then steadies before ductile failure. The ultimate flexural capacity of the heat-damaged beams did not considerably decrease in comparison to the control, according to test results on specimens 500-W-0 and 700-W-0. As seen in Fig. 18, a number of test specimens exhibited explosive spalling during heating. This was caused by the vapor pressure inside the specimen building up and the quick heating process not giving the pressure the time to release via the microcracks in the concrete.<sup>[48,49]</sup>
