Corrosion-Resistance Properties of Submarine Cable Steel Armor

Abstract

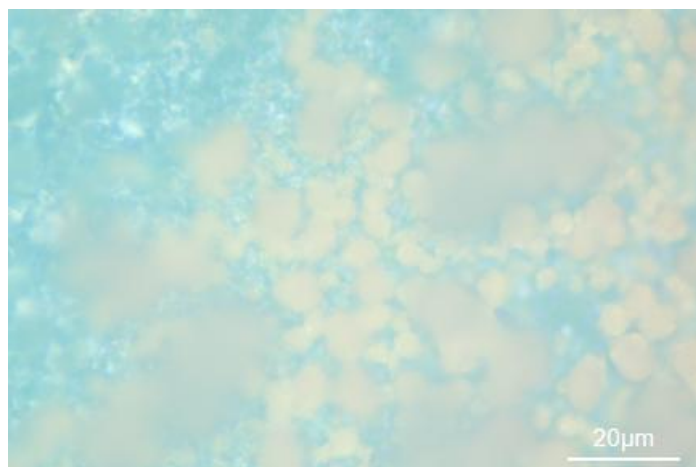
Fig. 3: Structural diagram of the steel corrosion products after artificial seawater immersion for 24 h.

in the artificial seawater for 24 h is shown in Fig. 2(b). A comparison between Figs. 2(a) and 2(b) reveals that, after 24 h of corrosion, the steel was severely corroded. However, the grain boundaries were unclear. A completely oxidized film was formed. Clean, clear grains and grain boundaries were not apparent. However, under a high-power microscope, it was evident that the corrosion products exhibited a point distribution. They varied in size and were yellow in color but exhibited an uneven distribution, as shown in Fig. 3.

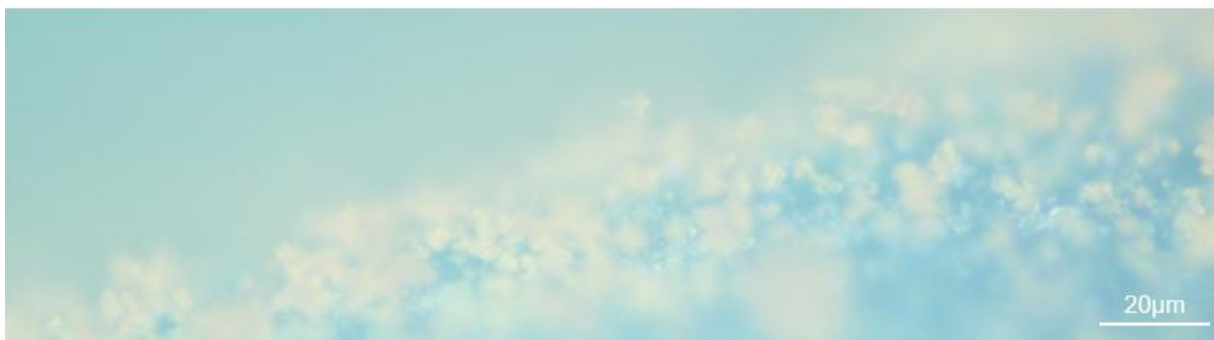
As shown in Fig. 6, corrosion began during pitting. The artificial seawater was a medium that typically caused pitting corrosion. After immersion in the corrosion solution for 5 min, dark-colored spotted corrosion pits appeared on the metallographic surfaces of the samples, owing to the chloride

ions in the artificial seawater destroying the passivation film of the zinc coating. After immersion corrosion for 24 h, the spots were connected over a large area, indicative of changes in the corrosion morphology.

Fig. 6: Steel edge corrosive pitting after 5% Na₂SO₄ immersion for 24 h.
